Self-Implementing On-Site Cleanup and Disposal Plan for PCB Caulking Removal

**Wethersfield High School
411 Wolcott Hill Road
Wethersfield, Connecticut
SDE Project No-080-0093 RNV/E**

Fuss & O'Neill EnviroScience, LLC
146 Hartford Road
Manchester, CT 06040

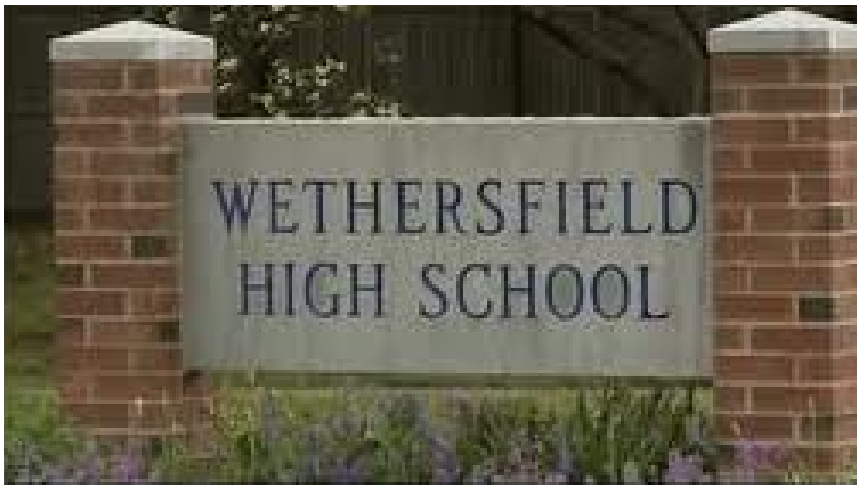
The building consists of approximately 279,608 square feet of classrooms, cafeteria, multi-purpose room, an interior in-ground pool, and music rehearsal rooms. The exterior of the building is concrete block and brick while interior walls are constructed of concrete block, wall board and brick, and plaster. Window systems are composed of metal. Figures HM-01 thru HM-05 shows the areas of the existing school.
